Report 1557-TR

PROTECTION AFFORDED BY  
FIELD FORTIFICATIONS AGAINST  
NUCLEAR WEAPONS EFFECTS (U)

8 December 1958

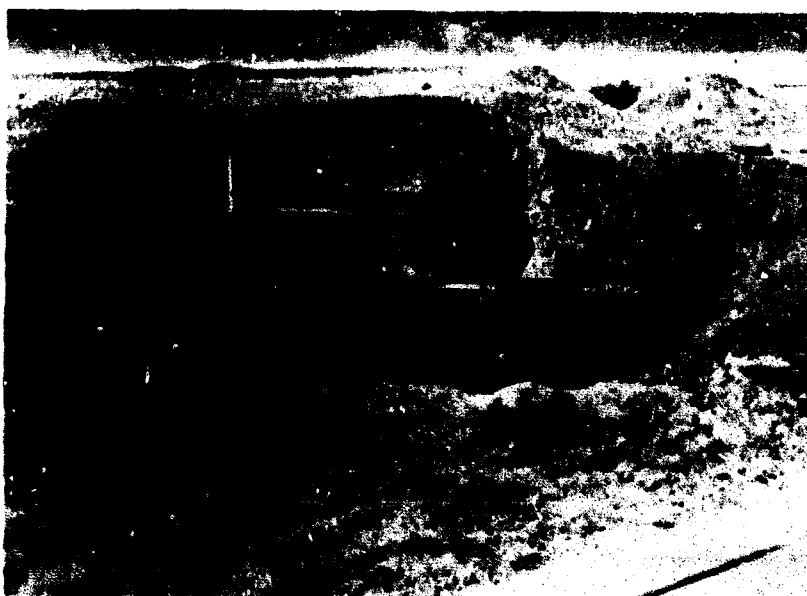
Figs. 29 through 35 show damage to the A1, A2, and A4 emplacements which were oriented rear-on to ground zero. (In the captions for several of these figures and succeeding figures, the reader is referred to the appropriate figure for a pre-test view of the subject being considered.) Rearward displacement (displacement away from ground zero) of the laminated roof on A1 was 5 in. relative to the cap at the side firing port while the opposite side seemingly remained fastened to the cap. The roofs on A2 and A4 were partially and completely removed, respectively, with the one on A2 being rotated counter clockwise approximately 45 degrees and the one on A4 being rotated counter clockwise approximately 90 degrees (see Figs. 32 and 34). The laminated roofs did not fail in bending. The emplacements of A1, A2, and A4 were leaning away from ground zero, and the amount of displacement at the caps increased from about 2 in. for A1 to about 4 in. for A4. Post failure was limited to one post, this being in the emplacement of A1 (see Fig. 31).

Fig. 34. Side view of A4, post shot (see Fig. 12).

than that transmitted by the entrance construction which contributed to the damage to the emplacements in the DESERT ROCK VI test. Although post displacement was as much as 4 in. for A4, no other damage was caused the substructure. Some lateral displacement is to be expected for construction of this type, and the amount obtained may be acceptable.

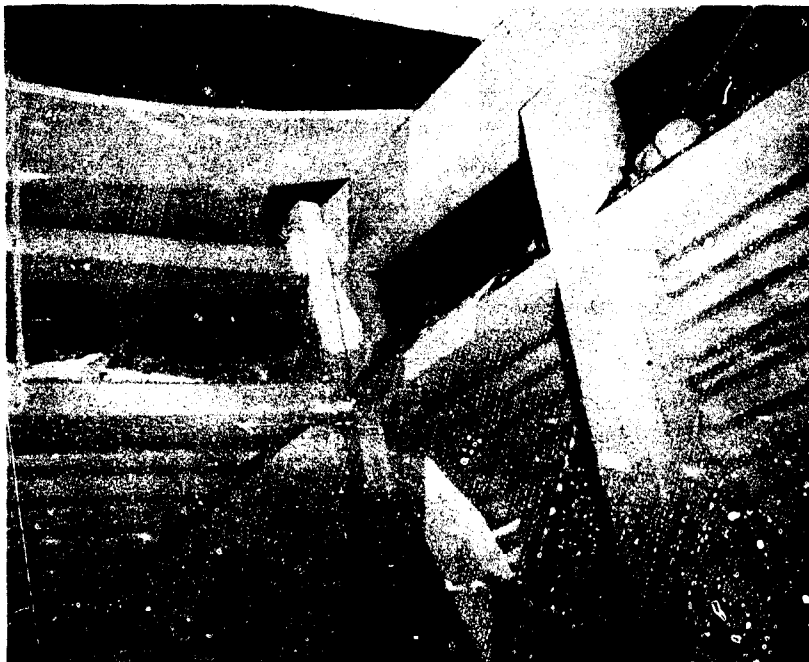
Fig. 35. Firing ports and roof of A4, post shot, looking from the direction of ground zero.

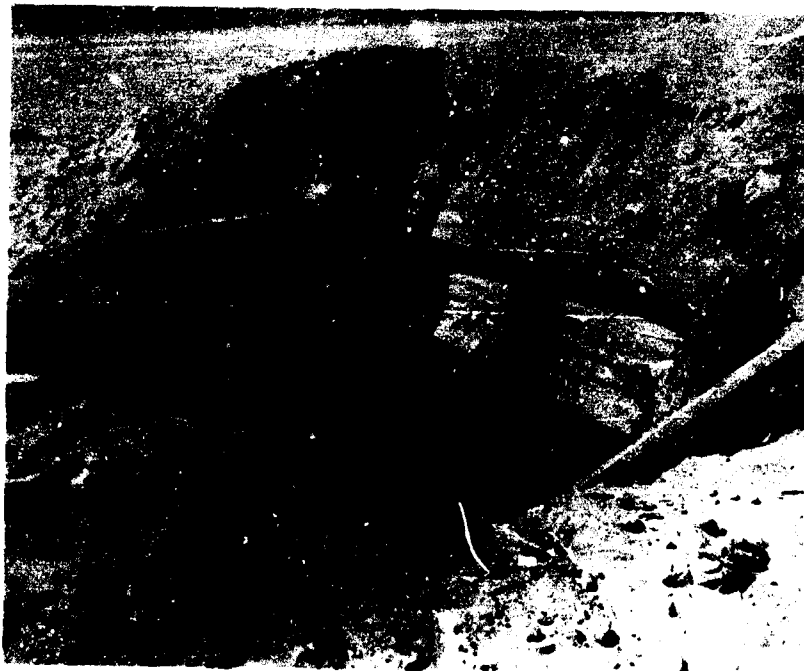
The emplacements of A3 and A5, which were oriented with the side firing ports toward ground zero, were destroyed. Figs. 36 and 37 show the damage to these emplacements. Fig. 38 shows the bottom of the laminated roof from A3. It had been standing on end and leaning against the leeward wall of the emplacement, but instrument recovery made it necessary to remove the roof before photographs were taken.

Fig. 36. Frontal view of A3, post shot (see Fig. 11).

No information was obtained about the vulnerability to blast of the laminated roofs on the emplacements of A3 and A5 because of the severe damage caused these emplacements by lateral forces. Damage to the roof on A3 (Fig. 38) may have been caused when the roof was slammed against the wall and floor of the emplacement. The laminated roofs on A1, A2, and A4 appear to have withstood the downward load of the blast overpressure to which they were exposed, but only the roof on A1 remained on the emplacement for the duration of the external load. Fig. 67 shows the inside overpressure records for the emplacements of A1 and A4 plotted on the outside overpressure records. (A pressure record was not obtained in the emplacement of A2.) The differences in arrival times of the blast wave at the gages at each distance would be slight, perhaps 6 or 8 ms, and are neglected in the figure. The figure shows that the peak inside overpressure was reached early in the loading phase and that it exceeded the outside overpressure, which had not yet reached a maximum, by roughly 4 psi for about 40 ms for A1 and by roughly 1.5 psi for about 75 ms for A4; but the total impulse resulting from this internal loading should not have been sufficient to cause removal of the roofs. Also, the fact that roof planks remained on the emplacement caps of A2 and A4 (see Figs. 32 and 34) indicates removal of the roof by other than internal pressure. The roofs on A1, A2, and A4 showed lateral displacement accompanied by rotation in the counter clockwise direction. It appears then that roof displacement was caused by drag winds impinging along the edge of the roof at the side firing port. This would not have occurred until after the roof was bared to these winds by the removal of the side firing port aprons. The roofs would have been more

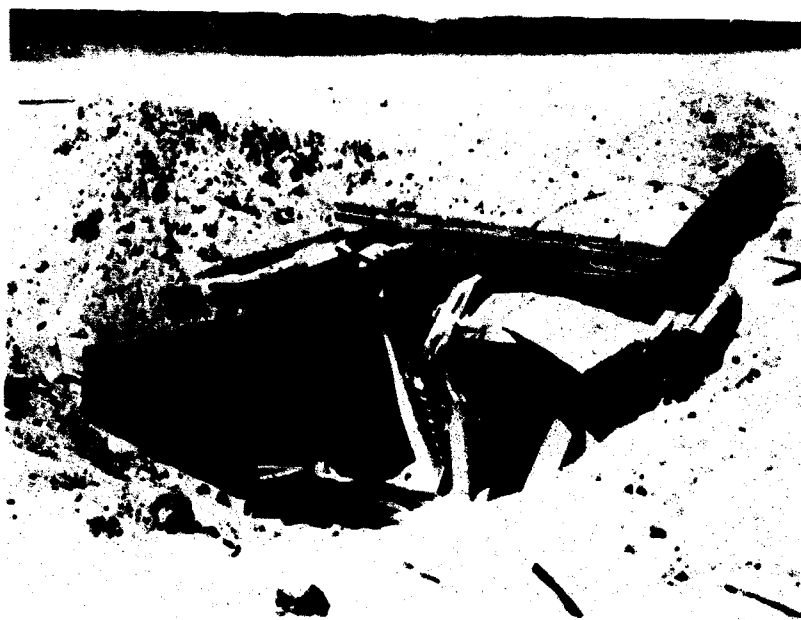
Fig. 37. Frontal view of A5, post shot (see Fig. 11).

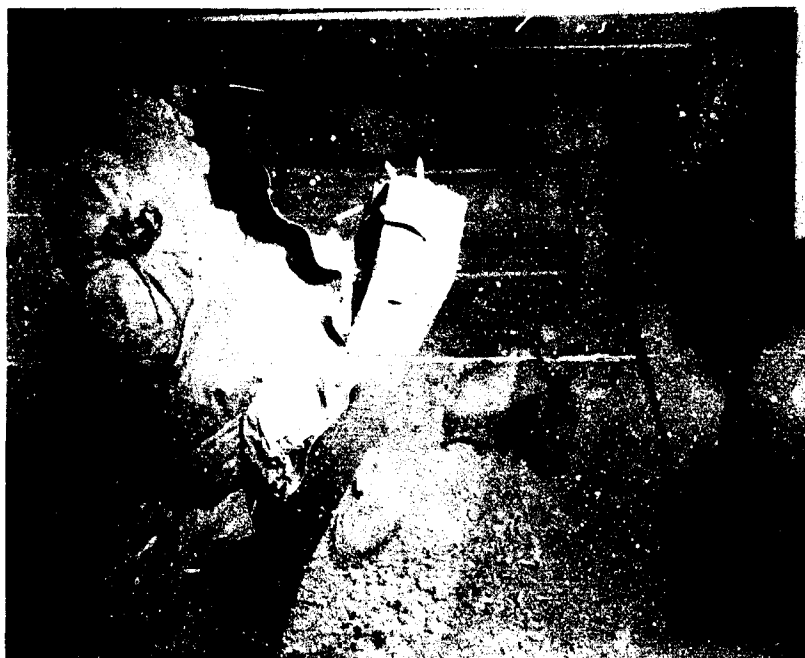
Figs. 39 through 52 describe the damage to the entrances and shelters of the machine gun emplacement. The entrance and part of the adjacent shelter of A1 were severely damaged (Fig. 39). Both caps along the entrance opening of A2 collapsed. Fig. 41 shows part of this debris but does not show the damaged section. The entrances of A3, A4, and A5 received minor structural damage; nevertheless, all entrance openings were nearly blocked by caved cover material. Figs. 50 and 51 show that the 6-in. by 6-in. roof stringers on the entrance of A5 were lifted from the caps; however, it should be pointed out that the supply of spikes which had been used to fasten these members to the caps were depleted, and for this fortification about one-half of the roof stringers were only toe nailed to the caps.

Fig. 48. Entrance opening to A4 as seen from inside structure, post shot (see Fig. 16).

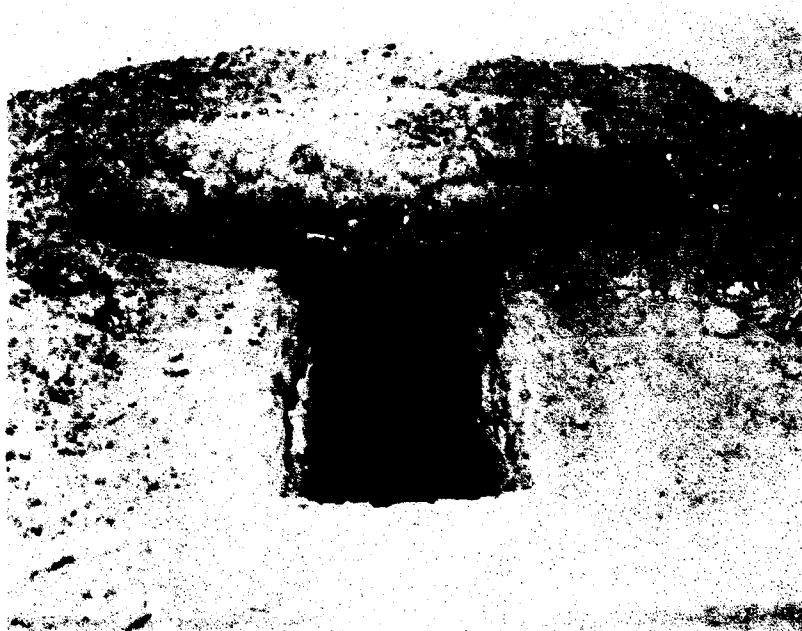
Fig. 57. View of B8, post shot.

b. Hasty Fortifications. Figs. 54 through 65 are photographs which show the effects of blast on some of the hasty fortifications. Not all of the fortifications are shown because the condition of any one fortification was representative of the condition of similar fortifications at the same distance from ground zero. Note in the figures listed above that some of the foxholes showed wall-spalling while others did not. The condition of the revetted tunnels of the offset foxholes is not apparent from the photographs. About one-half of the backfill material was removed from around the revetment in these tunnels. Damage to the earth arches at both distances (2280 and 3900 ft) appeared to be about the same as that to the unrevetted tunnel of D1 shown in Fig. 60. Blast within the tunnels caused no damage to the stick revetment in D4 and E4, but almost blew the end (bottom of oil drum) out of the rearmost section of revetment in E2. In E3, the end was fully rounded but completely intact. The peak overpressures recorded by the pt gages in the tunnels of E2 and E3 are given in Table VI. A pressure-time record was obtained in E3 (Fig. 66), but the gage in E2 recorded peak pressure only. Radiation measurements for the hasty fortifications are presented in Table VII.

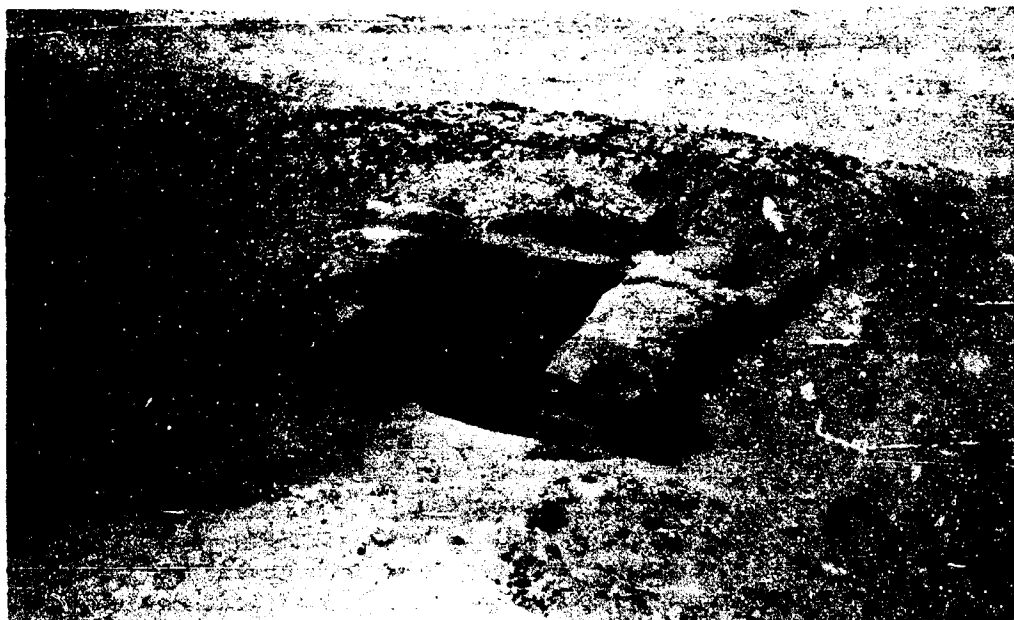
Fig. 64. View of F1, post shot, entrance facing ground zero (see Fig. 24).

Figs. 64 and 65 show that the damage to the hasty shelters amounted to removal of cover material from the front and sides. Apparently, the sandbags used to close the entrance of F2 (Fig. 65) prevented the blast from separating the roof stringers as it did at the entrance of F1 (Fig. 64).
